USACERL Interim Report FM-94/08  
April 1994

## Field Test Results of Corrosion-Resistant Coatings for Carbon-Steel Steam Condensate Return Lines

by  
Vincent F. Hock  
Henry Cardenas  
James R. Myers

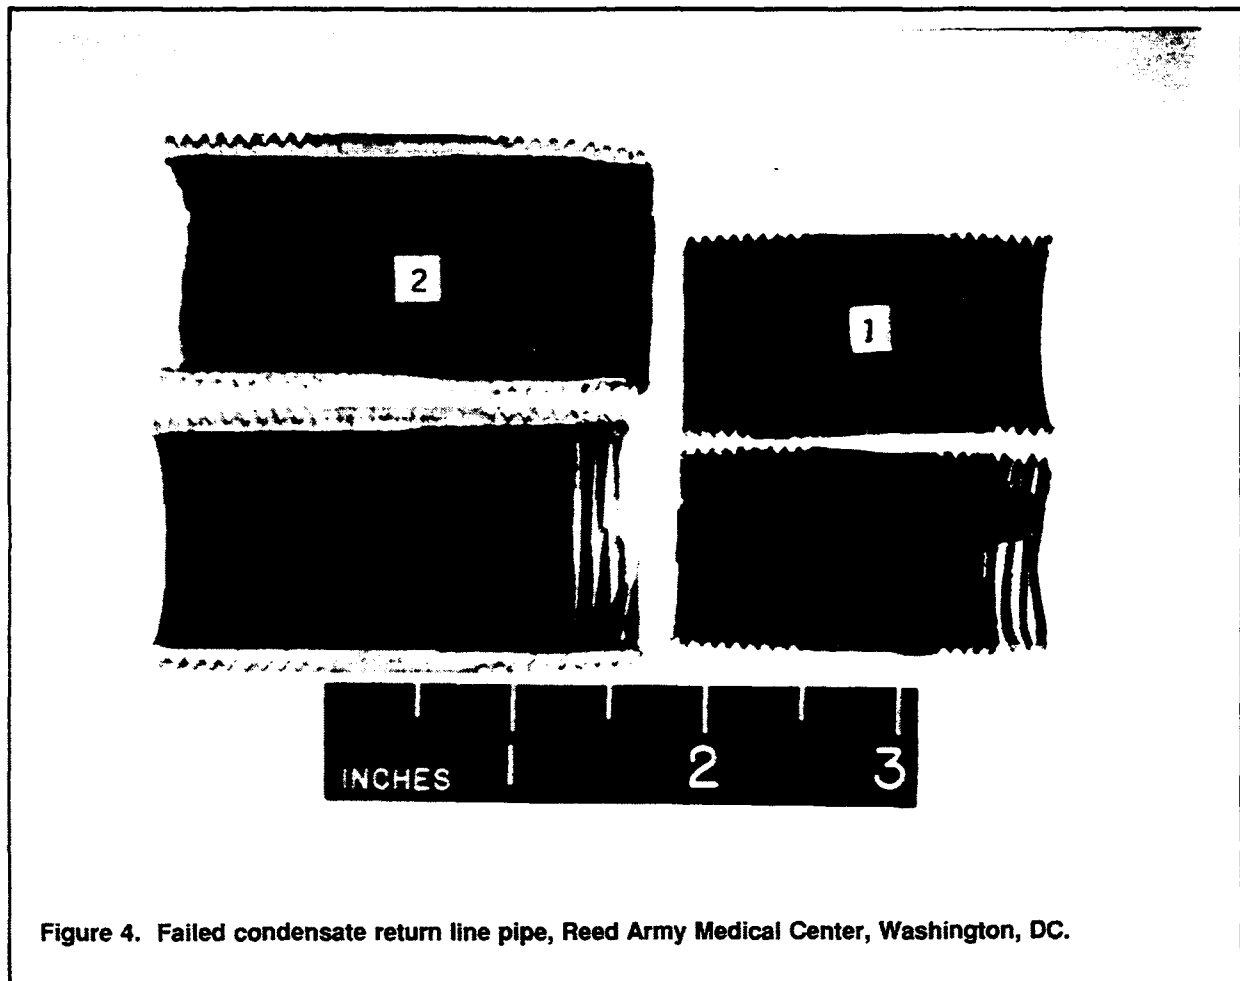
Water is dealkalized at a rate of 20 gal per minute (gpm). A major building addition has developed a serious bypass flow. Nondealkalized water enters the makeup stream at a rate of 35 gpm. Under these circumstances, the condensate water typically exhibits pH values less than 6. The resulting corrosion rates are relatively high. Small diameter, schedule 40, carbon-steel condensate return lines often incur thread area leaks within 2 years of installation. Figure 4 shows samples of failed condensate return line specimens taken from the Medical Center on 26 May 1989. The specimens taken from a horizontal section contain thread area leaks induced by CO<sub>2</sub> grooving or channeling following 2 years of service. Corrosion occurred along the bottoms of the pipes. No O<sub>2</sub>-induced corrosion was observed. Also, the pipe wall areas not affected by grooving or channeling retained sufficient thickness to meet the requirements for schedule 40 carbon-steel pipe.

Figure 4. Failed condensate return line pipe, Reed Army Medical Center, Washington, DC.
